**POST EARTHQUAKE DAMAGE AND USABILITY
ASSESSMENT OF BUILDINGS: FURTHER
DEVELOPMENT AND APPLICATIONS**

FINAL REPORT

**EUROPEAN COMMISSION - D.G. ENVIRONMENT
CIVIL PROTECTION - EPPO**

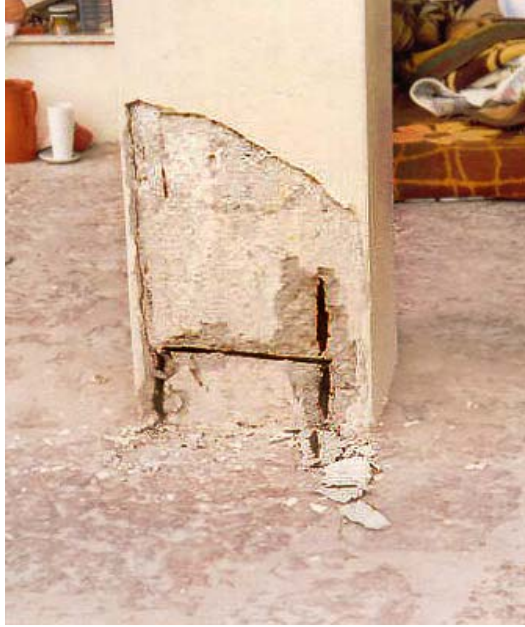
Photo 1: Damage severity 1

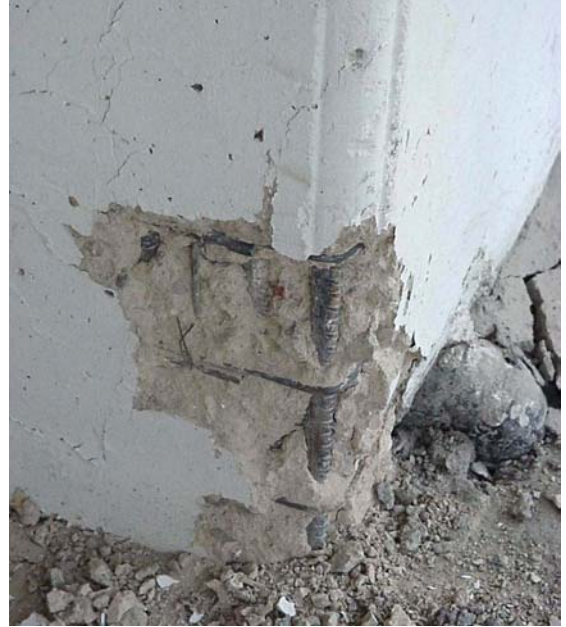
Photo 2: Damage severity 1

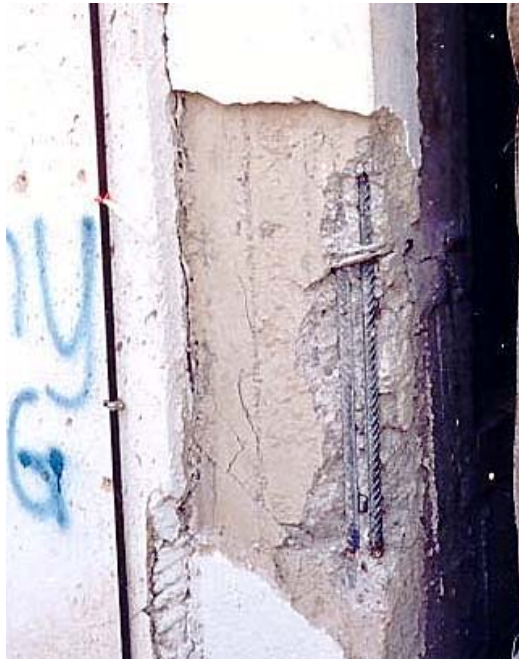
Photo 3: Damage severity 2

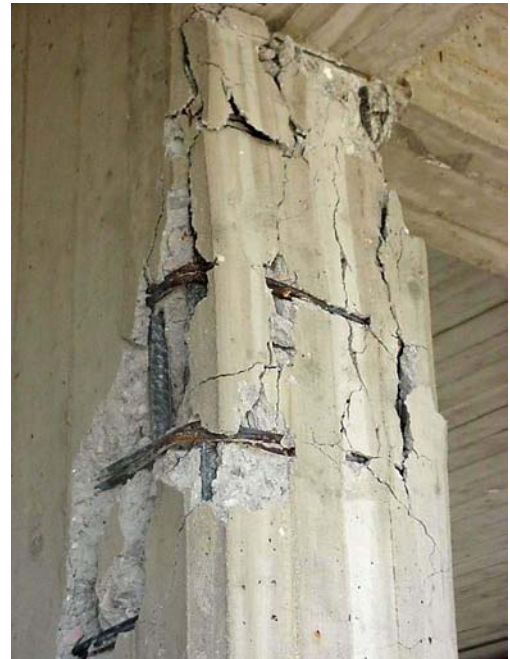
Photo 4: Damage severity 3

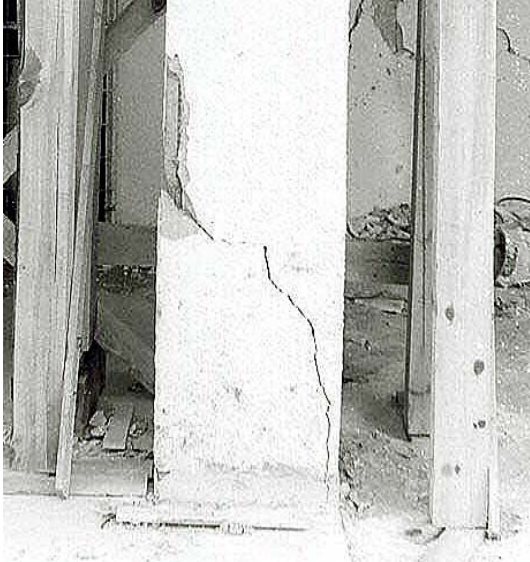
Photo 5: Damage severity 3

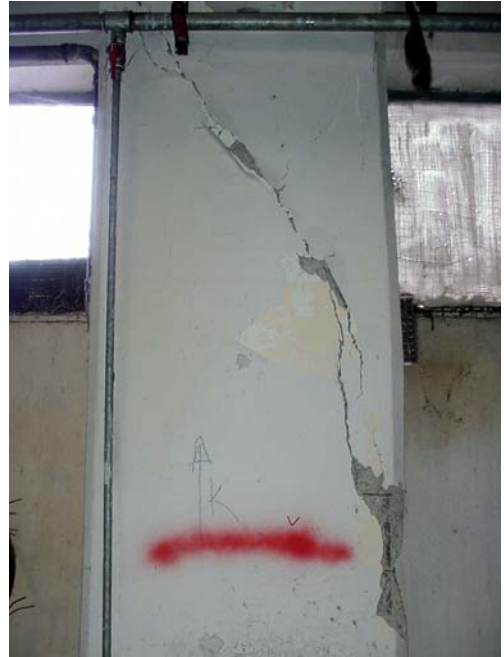
Photo 6: Damage severity 3

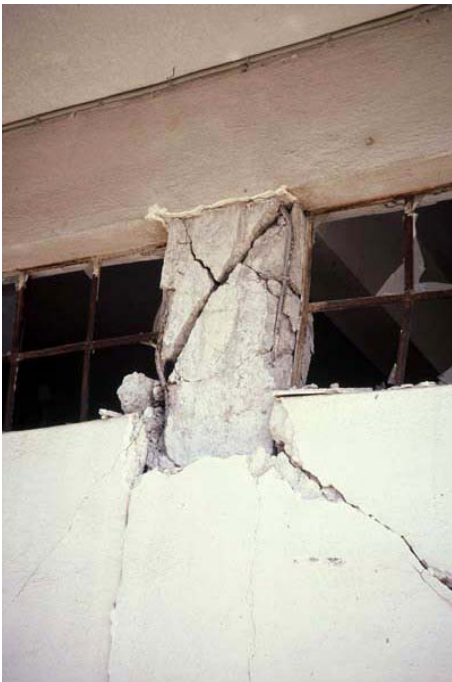
Photo 7: Damage severity 4

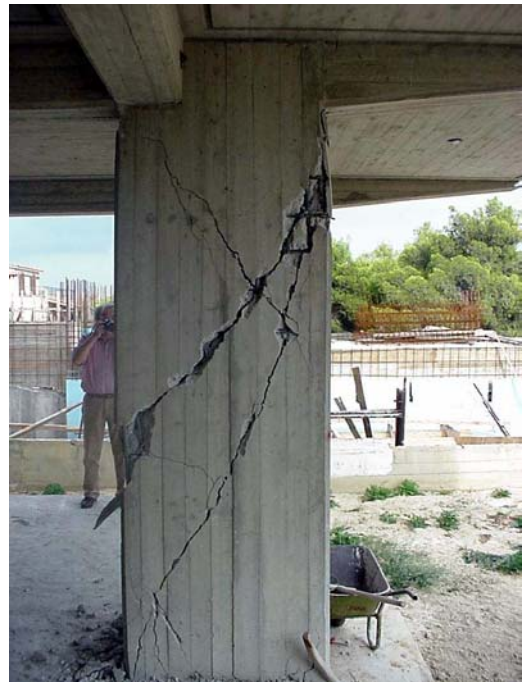
Photo 8: Damage severity 4

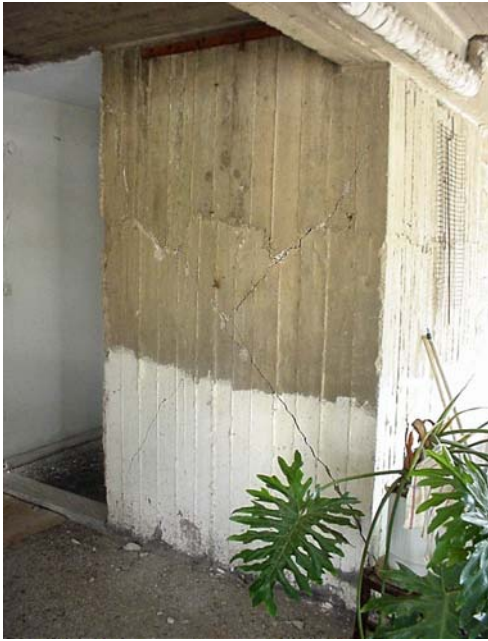
Photo 9: Damage severity 2-3

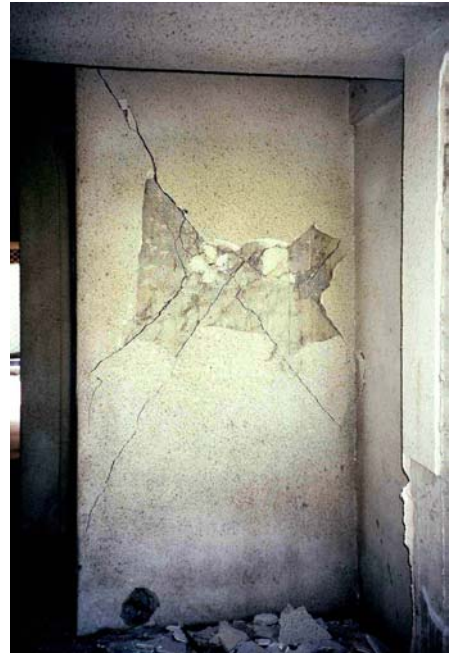
Photo 10: Damage severity 2-3

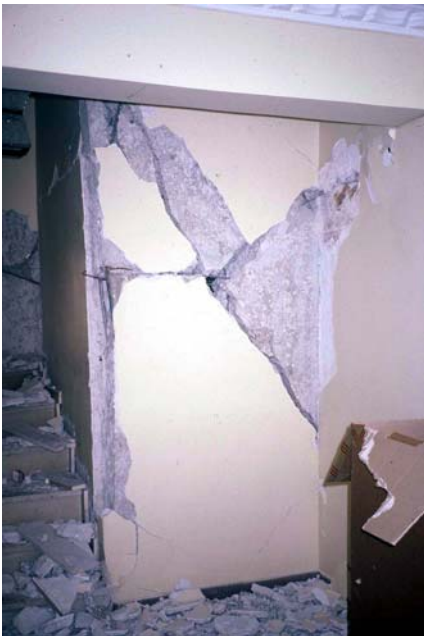
Photo 11: Damage severity 4

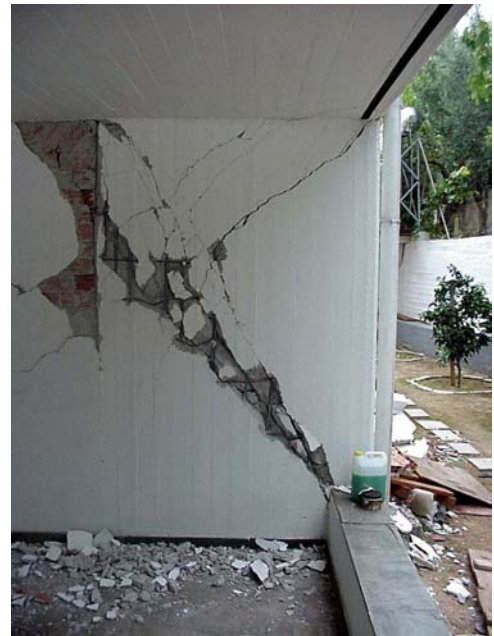
Photo 12: Damage severity 4

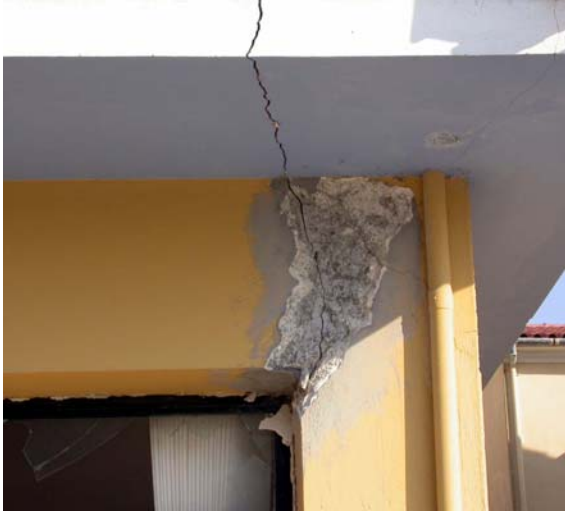
Photo 13: Damage severity 2

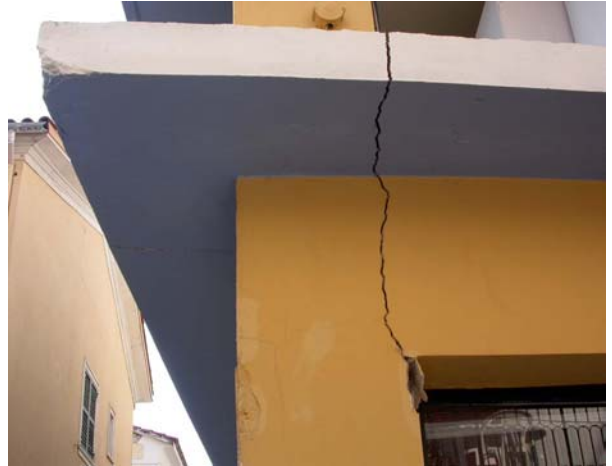
Photo 14: Damage severity 2-3

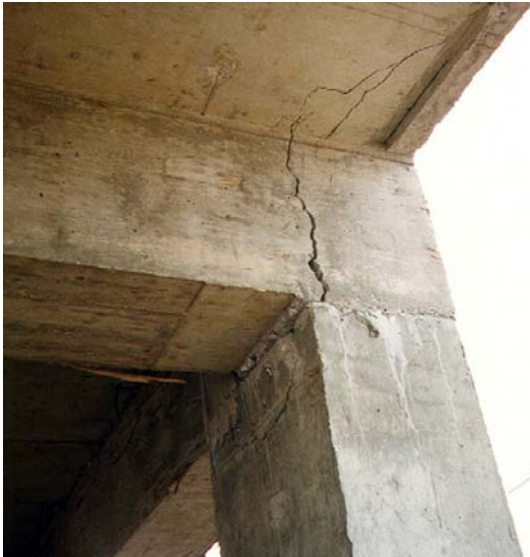
Photo 15: Damage severity 3

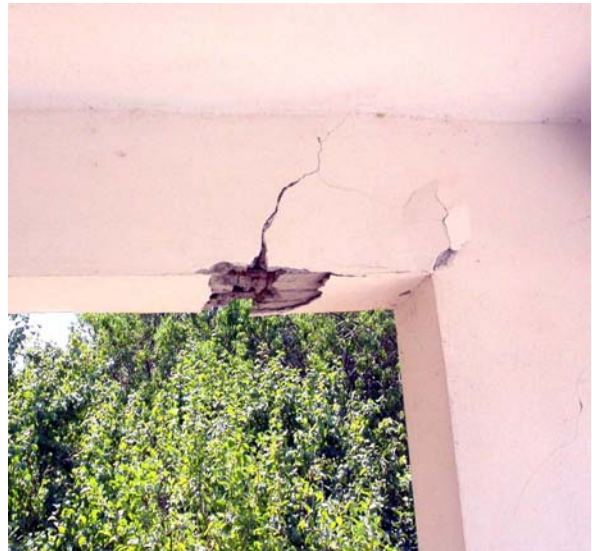
Photo 16: Damage severity 3

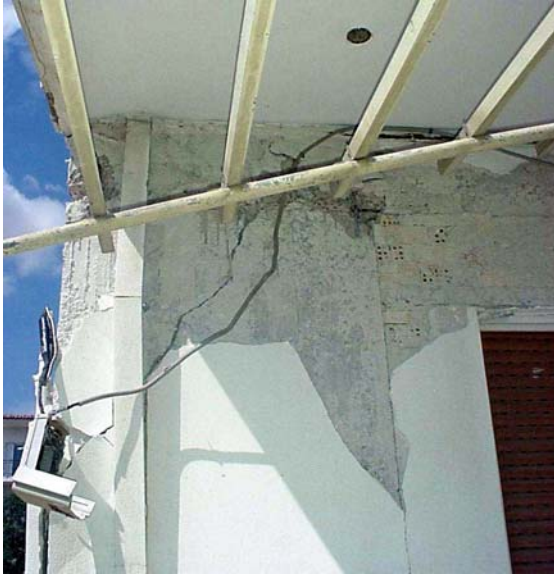
Photo 17: Damage severity 3

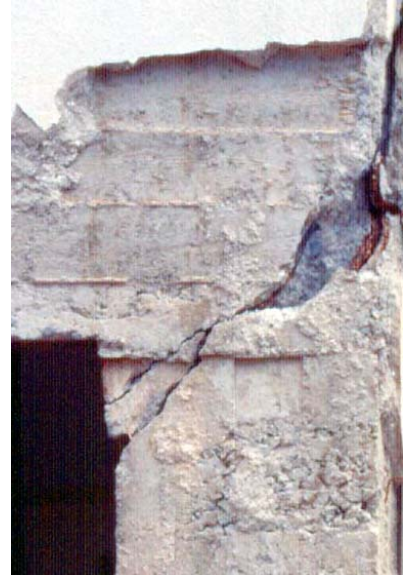
Photo 18: Damage severity 4

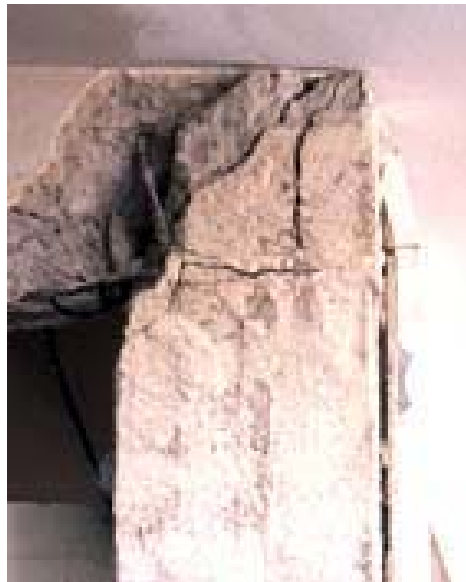
Photo 19: Damage severity 4

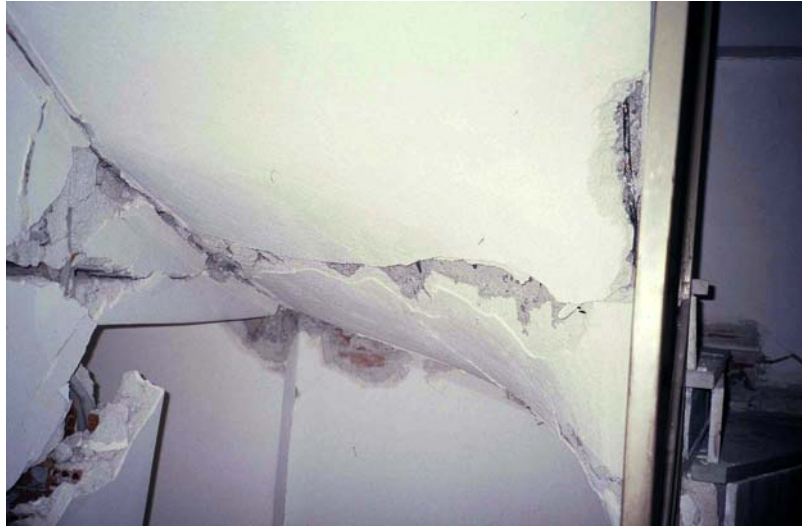
Photo 20: Damage severity 2-3

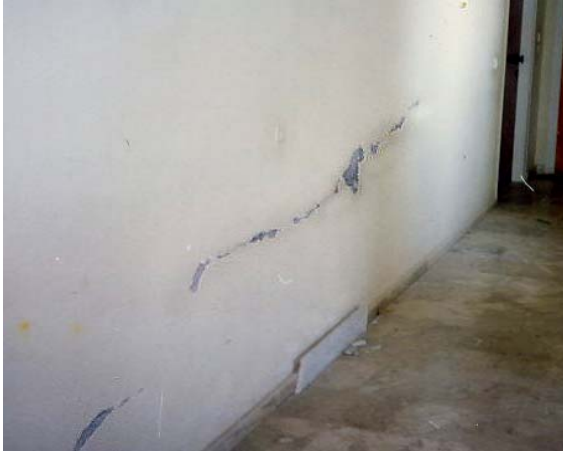
Photo 21: Damage severity 1-2

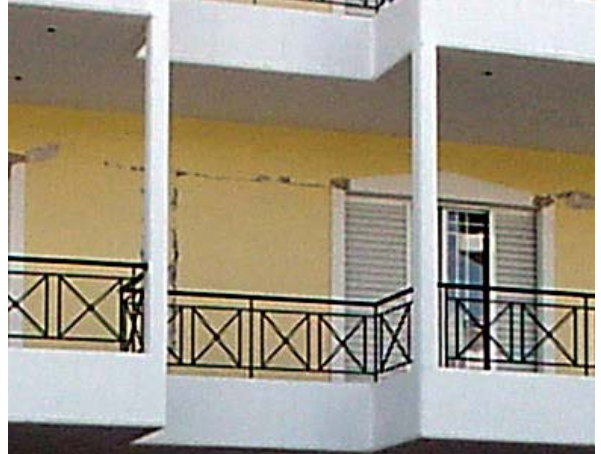
Photo 22: Damage severity 2

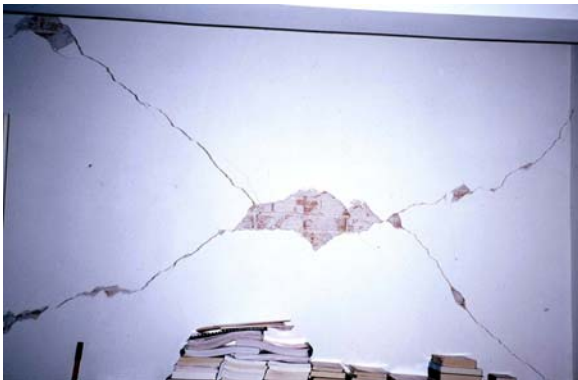
Photo 23: Damage severity 3

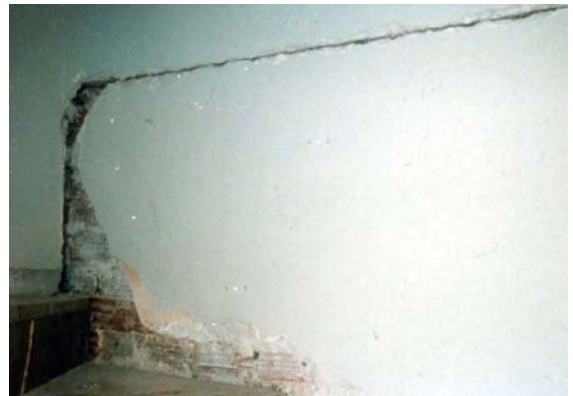
Photo 24: Damage severity 3

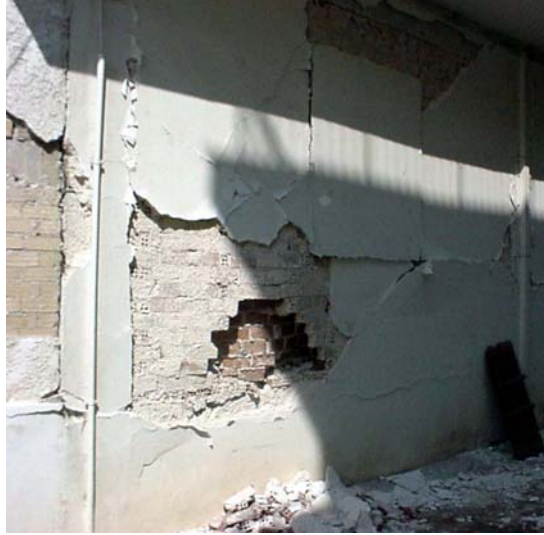
Photo 25: Damage severity 4

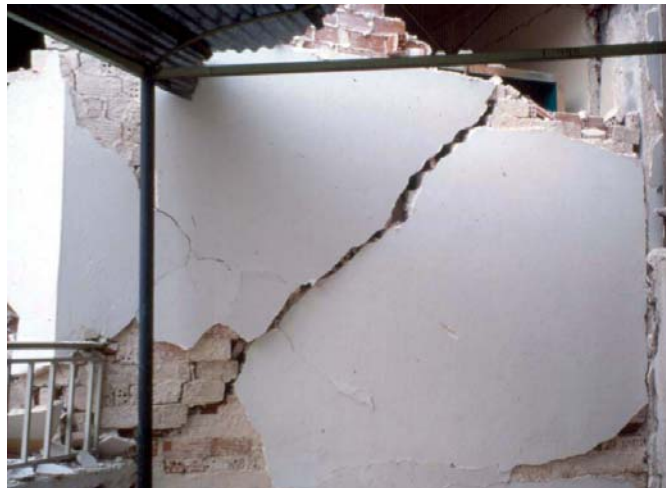
Photo 26: Damage severity 4

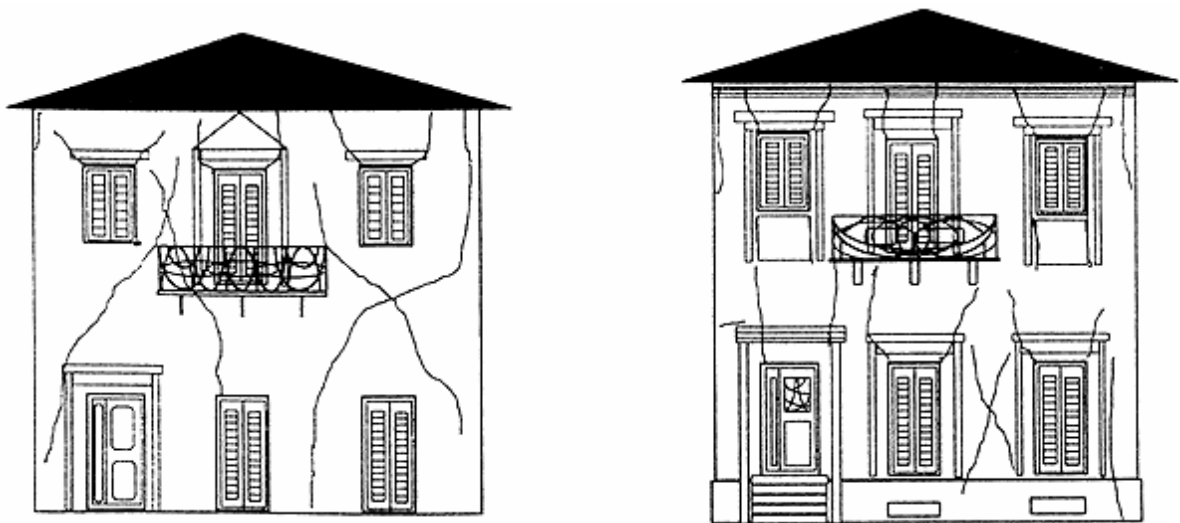
Exhibit 2.6: Typical damage patterns of masonry buildings

In Table 2.2 and in Exhibit 2.7 the levels of Damage Severity of Masonry buildings are related to the expected modes of failure. Exhibit 2.6 shows typical crack patterns in the exterior walls of Masonry buildings.

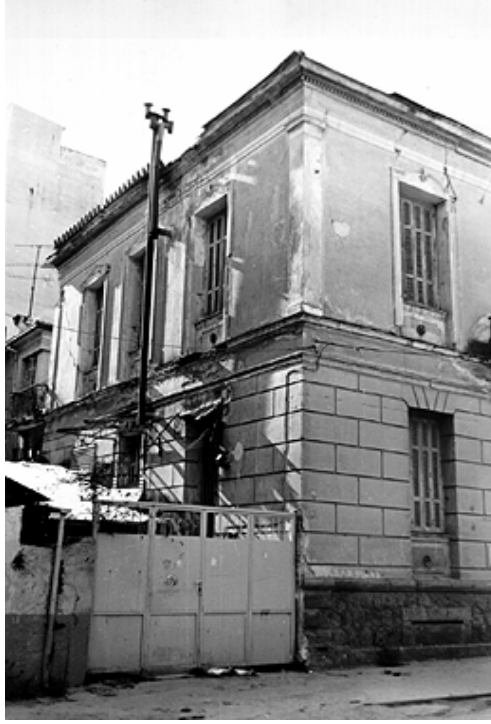
Photo 27: Slightly damaged (GREEN)

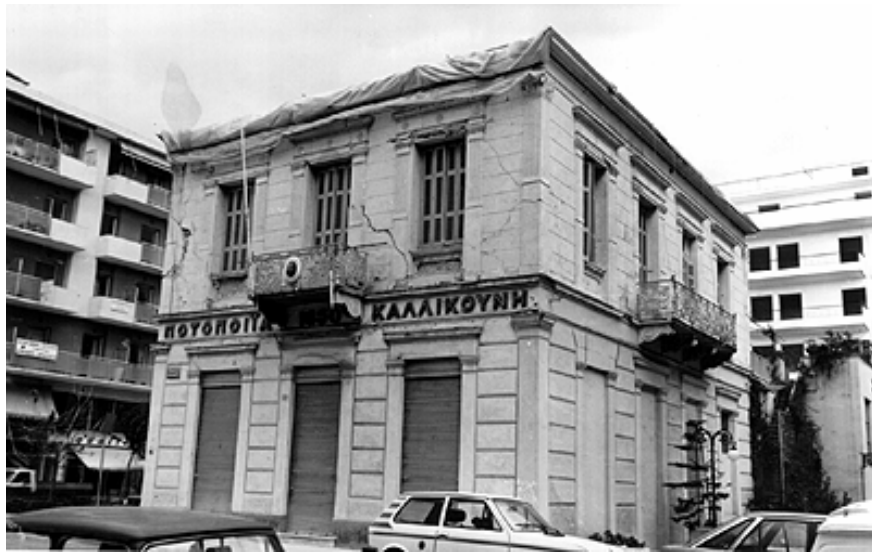
Photo 28: Slightly damaged (GREEN)

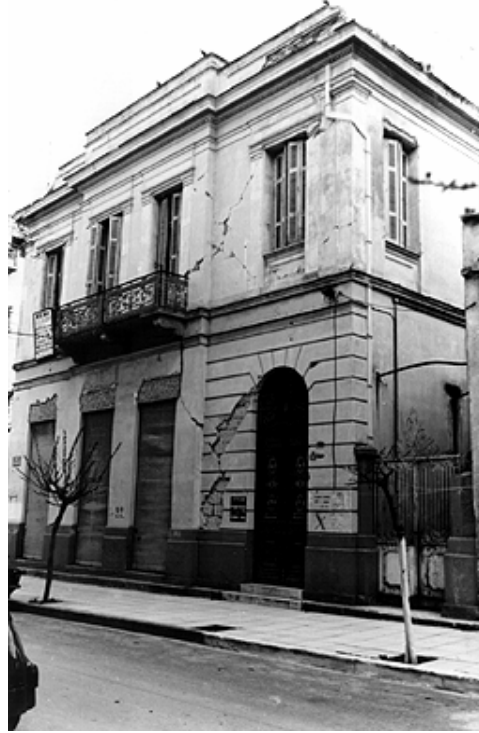
Photo 29: Moderate to heavy damage (YELLOW)

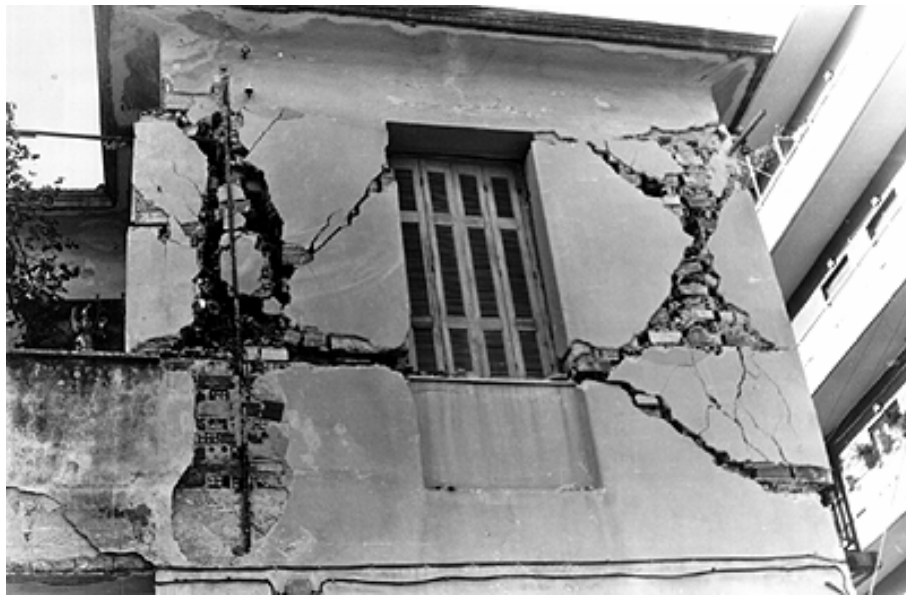
Photo 30: Severe damage (RED)

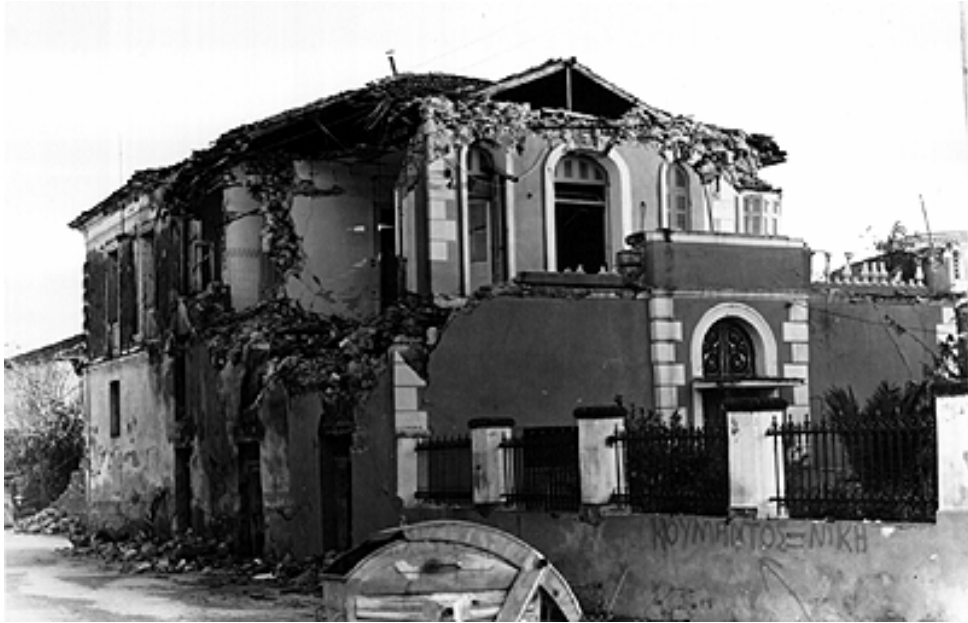
Photo 31: Partial collapse (RED)

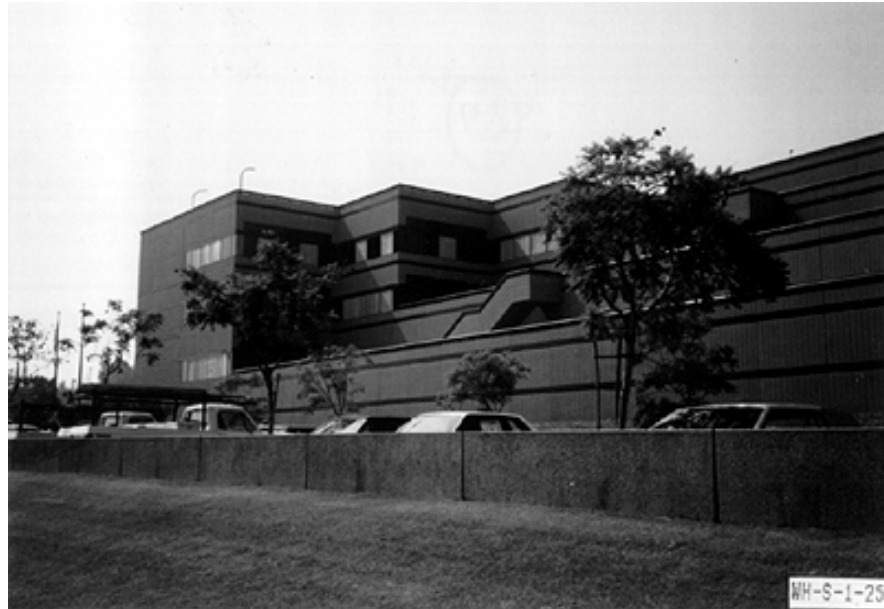
Photo 33: Four storey steel building with extensive broken glass and several buckled braces (YELLOW)

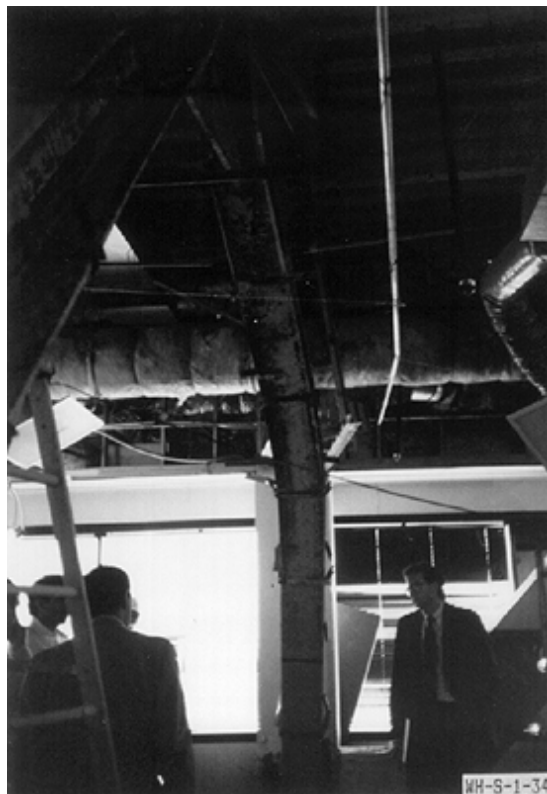
Photo 34: Buckled brace of building in Photo 29

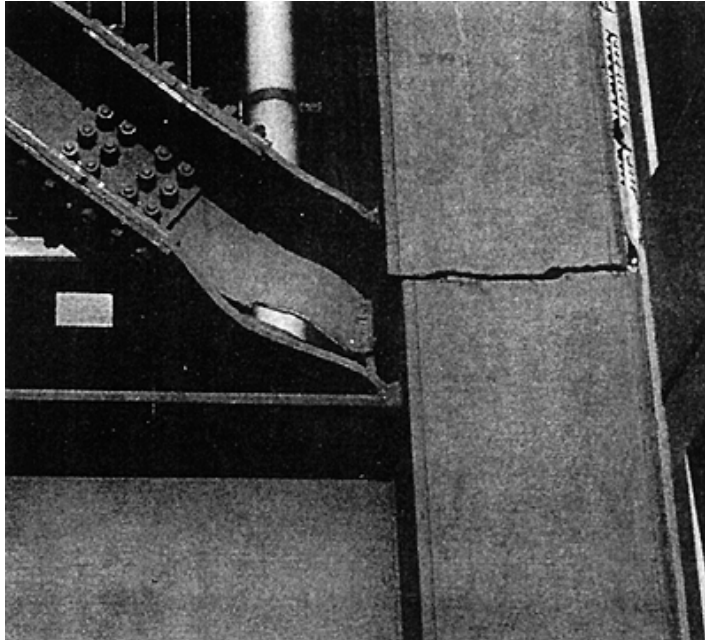
Photo 35: Complete column fracture and brace failure (YELLOW)

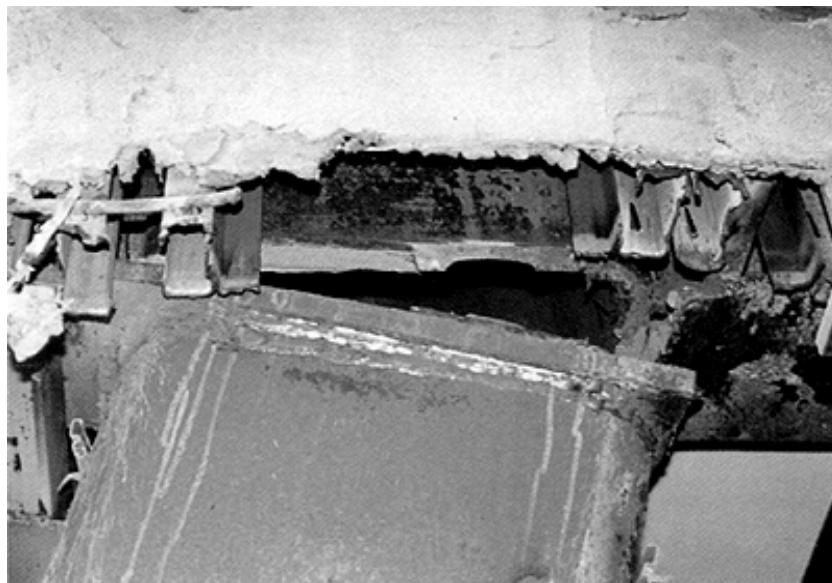
Photo 36: Fractured weld of the panel plate in beam-column joint (YELLOW)

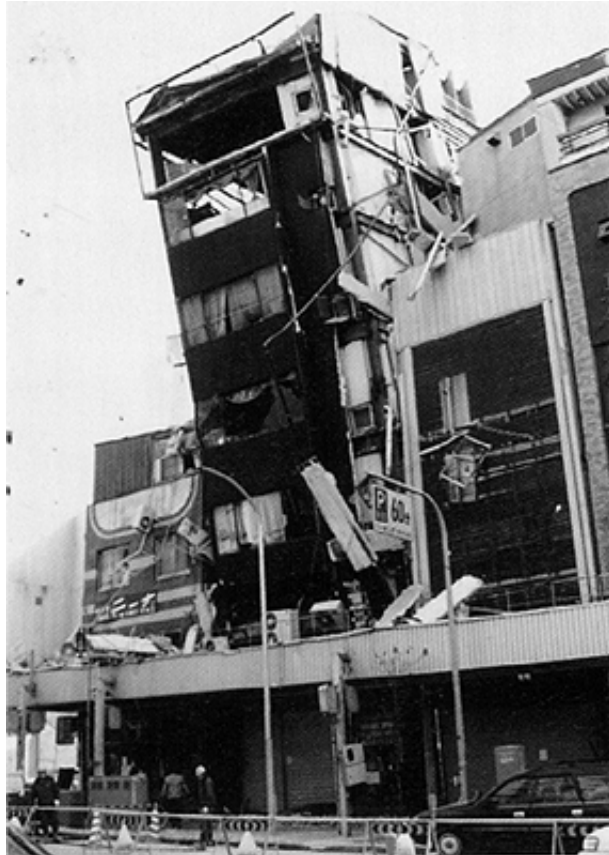
Photo 37: Failed 7-story braced steel frame building (RED)

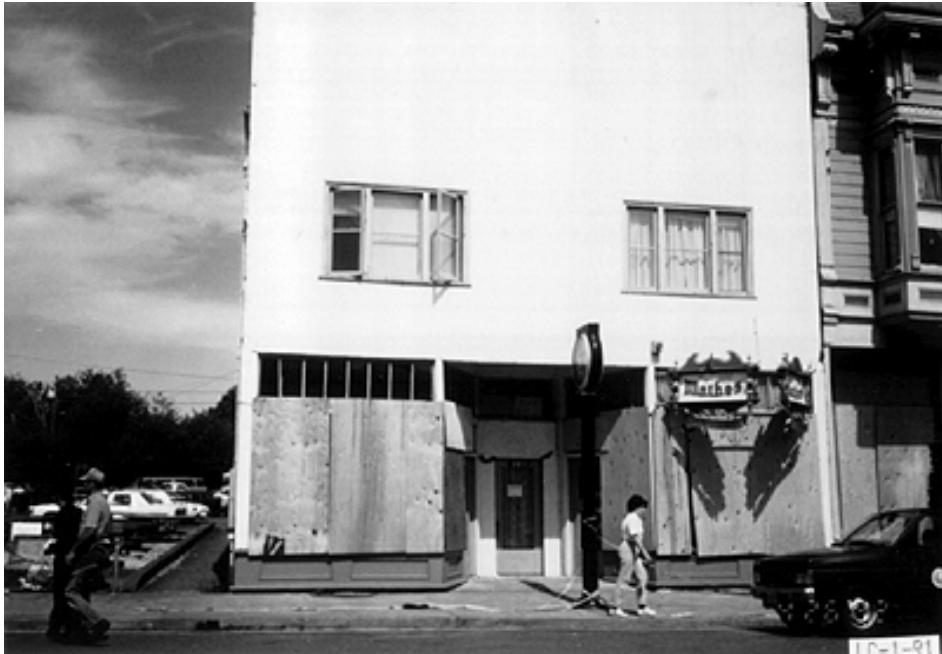
Photo 38: Damaged 2-storey wood frame building. Lots of broken glass and some lateral offset (YELLOW)

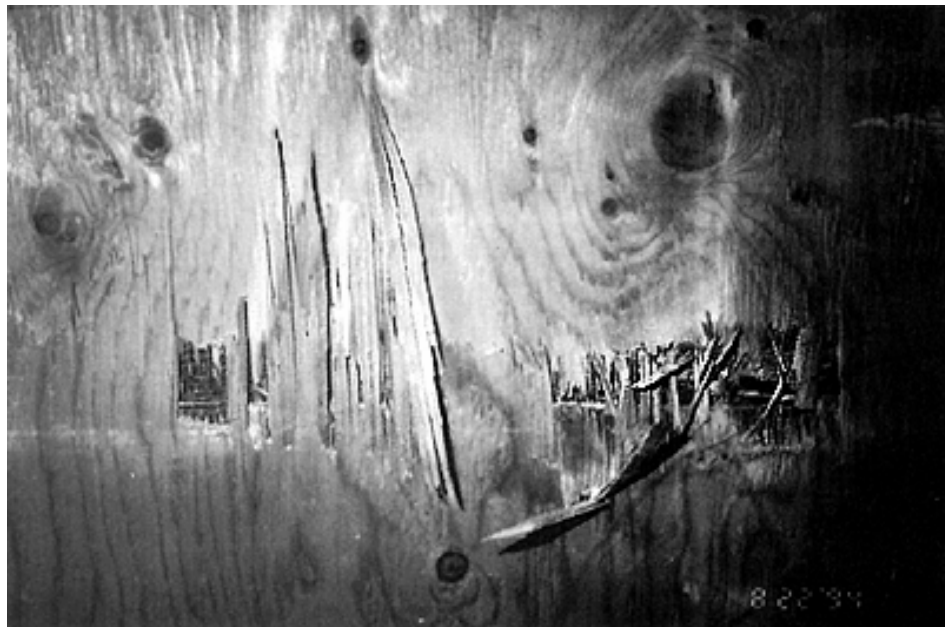
Photo 39: Local damage to plywood shear wall (YELLOW)

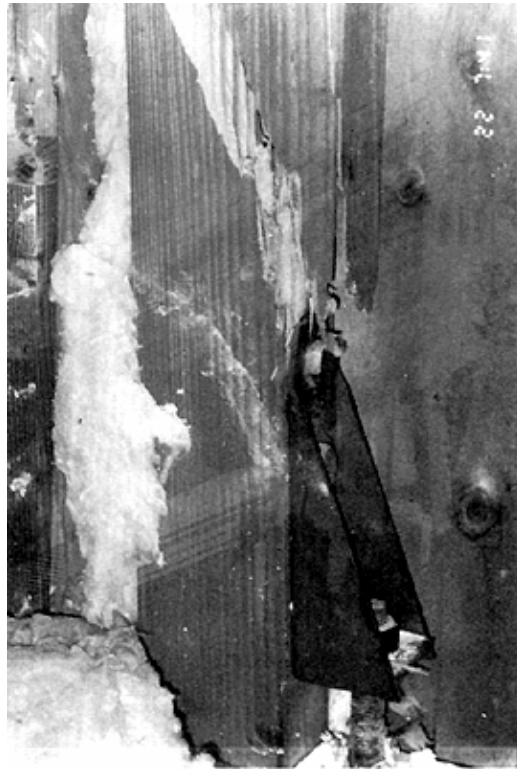
Photo 40: Fractured post above the hold-down (YELLOW)

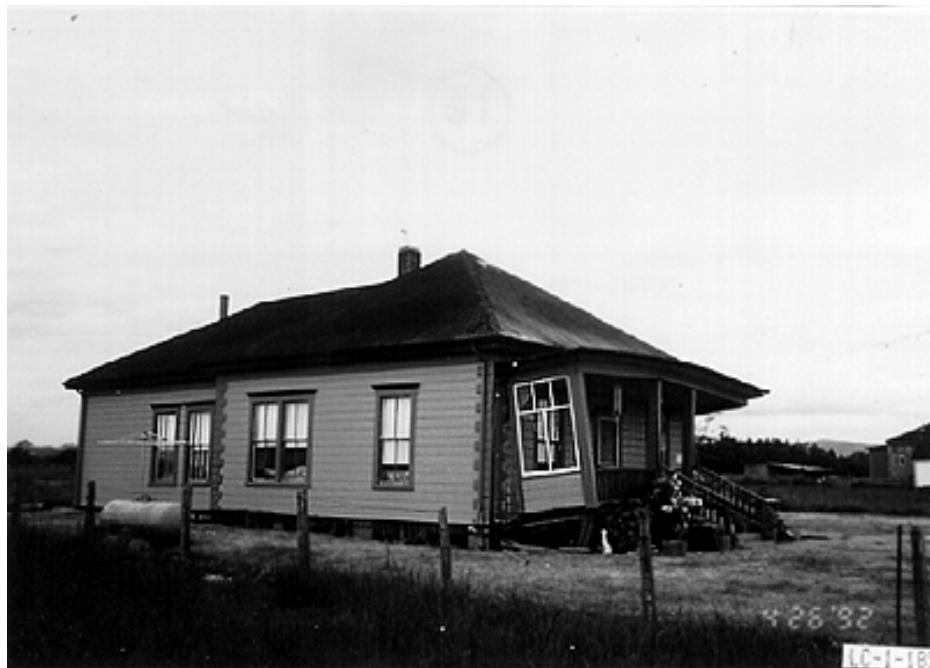
Photo 41: Single story wood frame house slipped off its foundation (RED)

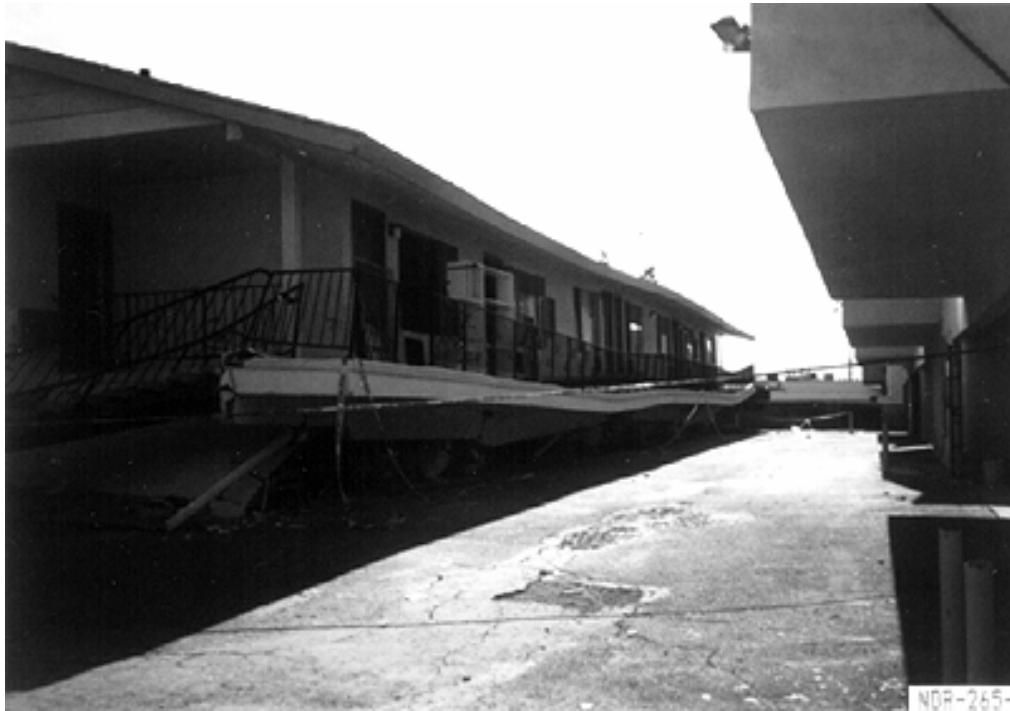
Photo 42: Collapsed 2-story wood frame apartment building (RED)

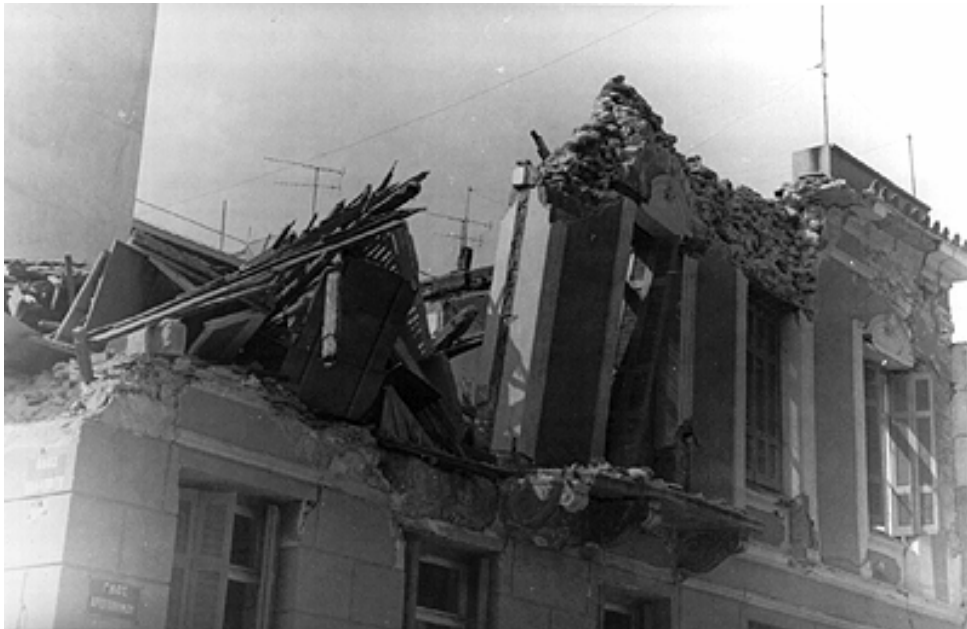
Photo 45: Hazardous, partially collapsed masonry building requiring urgent demolition

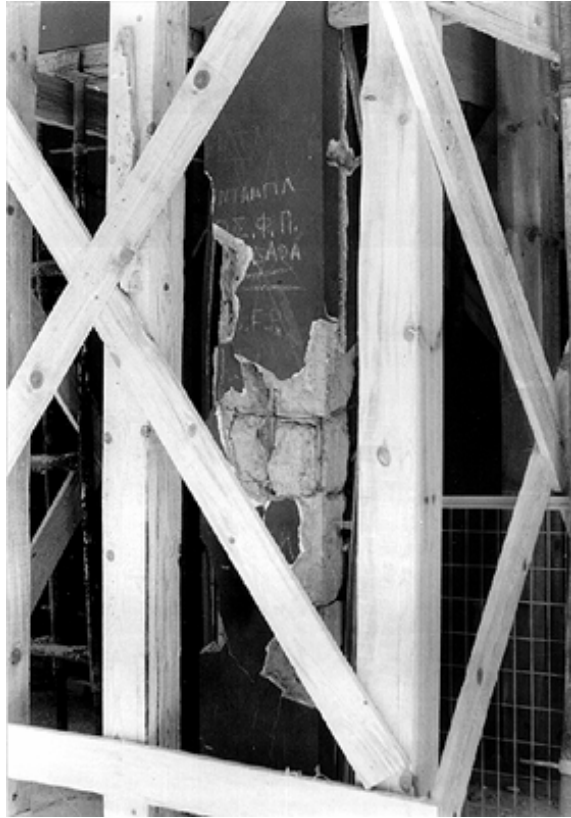
Photo 46: Emergency support due to failed column

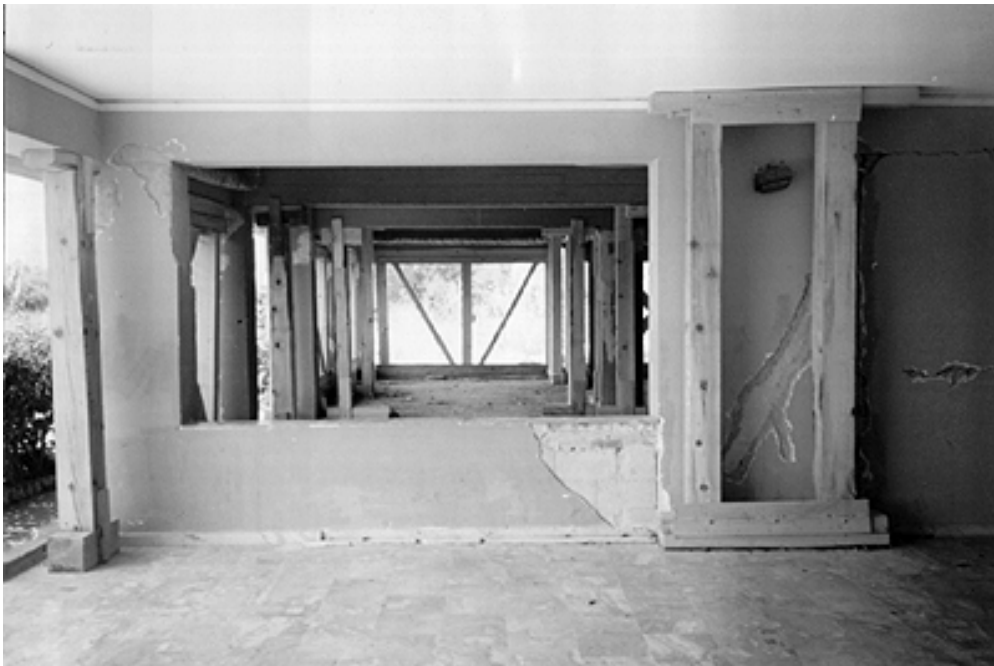
Photo 47: Emergency support of damaged open ground story of concrete building

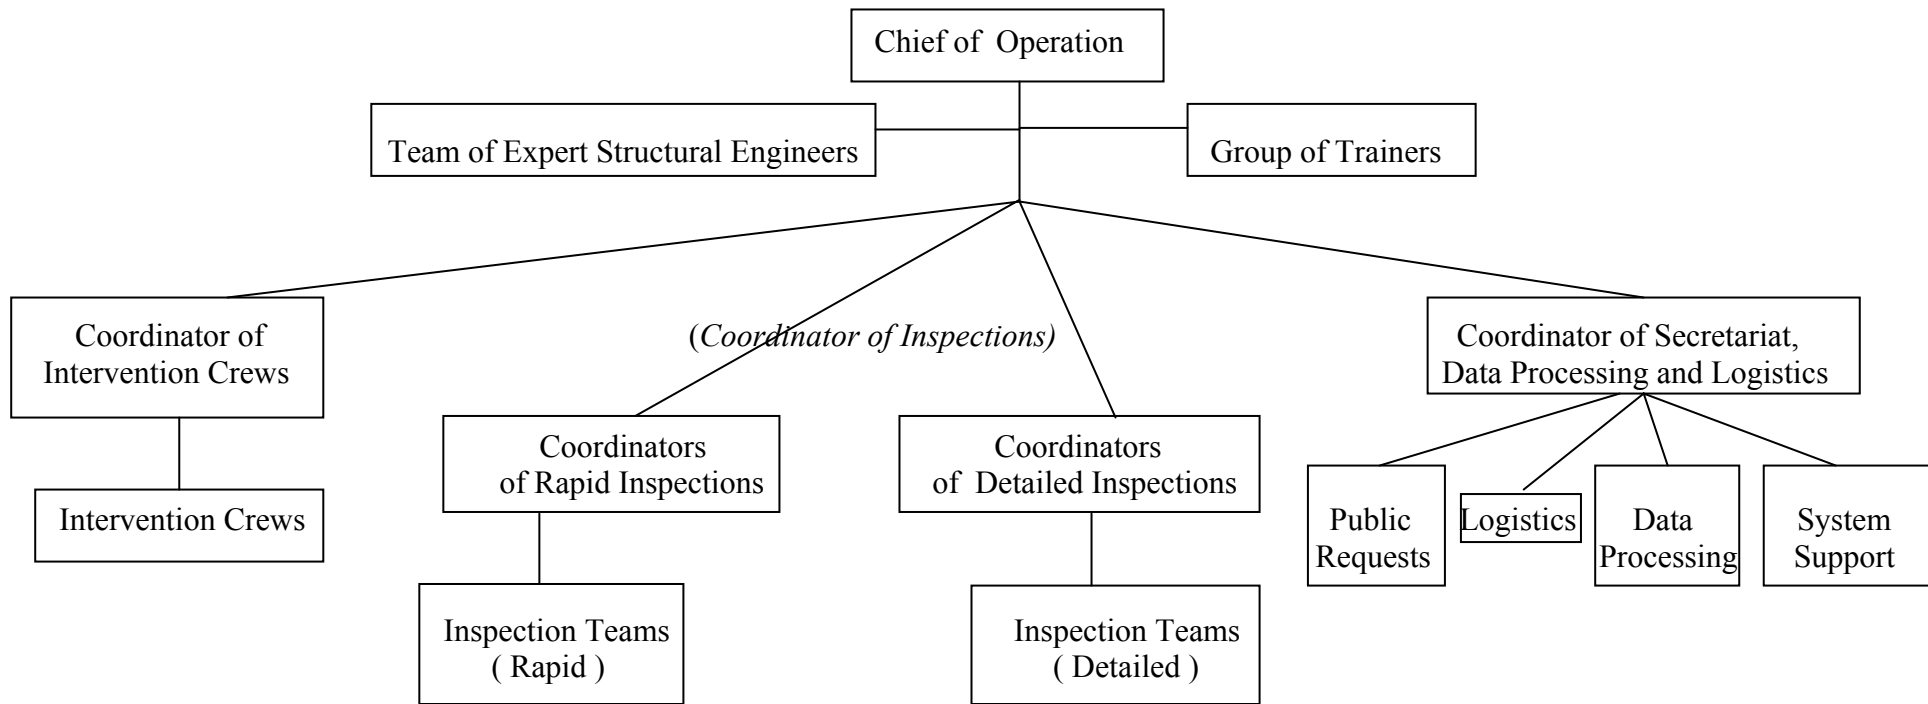
Exhibit 3.1: Organizational structure for a large scale emergency damage inspection operation.
